**Report No. UT-05.06**

**CONCRETE BRIDGE DECK  
MANAGEMENT PRACTICES:  
SUMMARY OF SCANNING TOUR**

**Final Report**

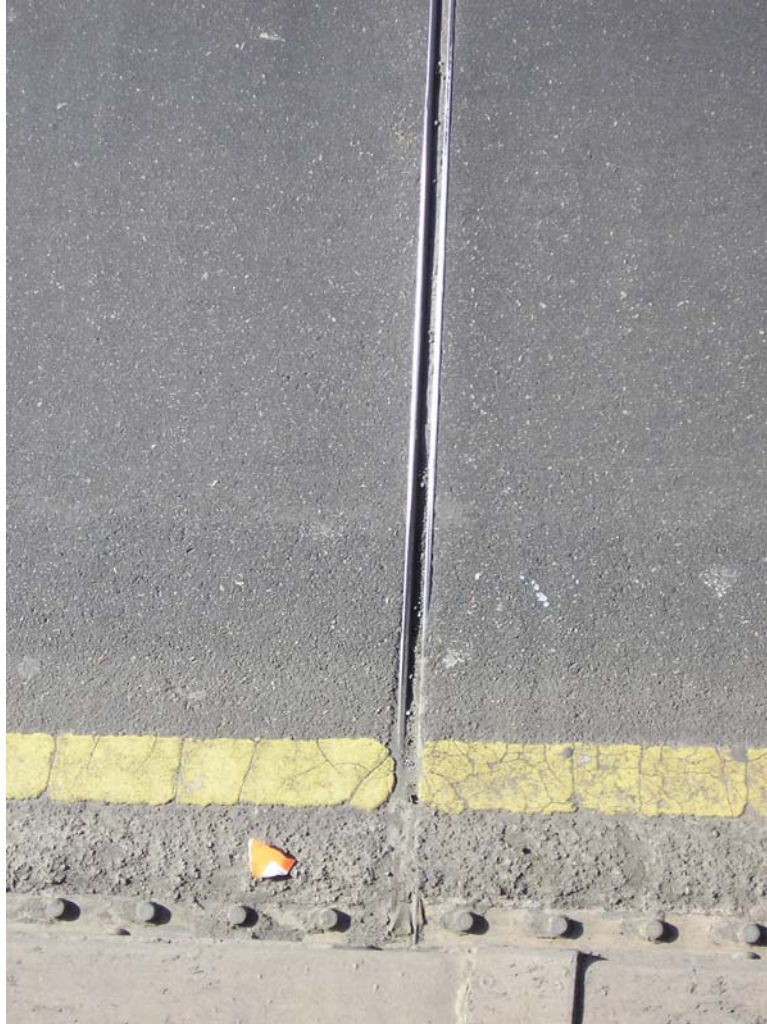
**FIGURE 2.4 Transverse relief joint on Brooklyn Bridge deck.**

Transverse relief joints were placed every 30 ft longitudinally along the deck; an example is given in Figure 2.4. The precast panels were bolted in place, and the joints were seal welded and filled with hot tar before the wearing

course was placed. Orthotropic decks, which are galvanized, concrete-filled steel slabs, were used even though their flexibility can occasionally cause spalling of the wearing surface. In 1980 a Flexolith product had been applied to the bridge deck surface and provided about 12 years of service before failing due to poor bonding. That surface was removed by hydroblasting before a new surface was applied. A two-course surface layer is typically specified for the bridge, where thinner layers have been observed to be more stable than thicker layers. Microsurfacing wearing courses used on the bridge usually provide 5 to 6 years of life; the primary failure mode is thinning in the wheel paths as illustrated in Figure 2.5. An intact substrate is critical for achieving adequate compaction of the wearing course. Kulczycki commented that the wearing course in one direction is performing much better than the wearing course in the other direction because in the latter case, rain fell within 5 hours of the project completion. The existing wearing course is comprised of Trinidad Lake Asphalt.

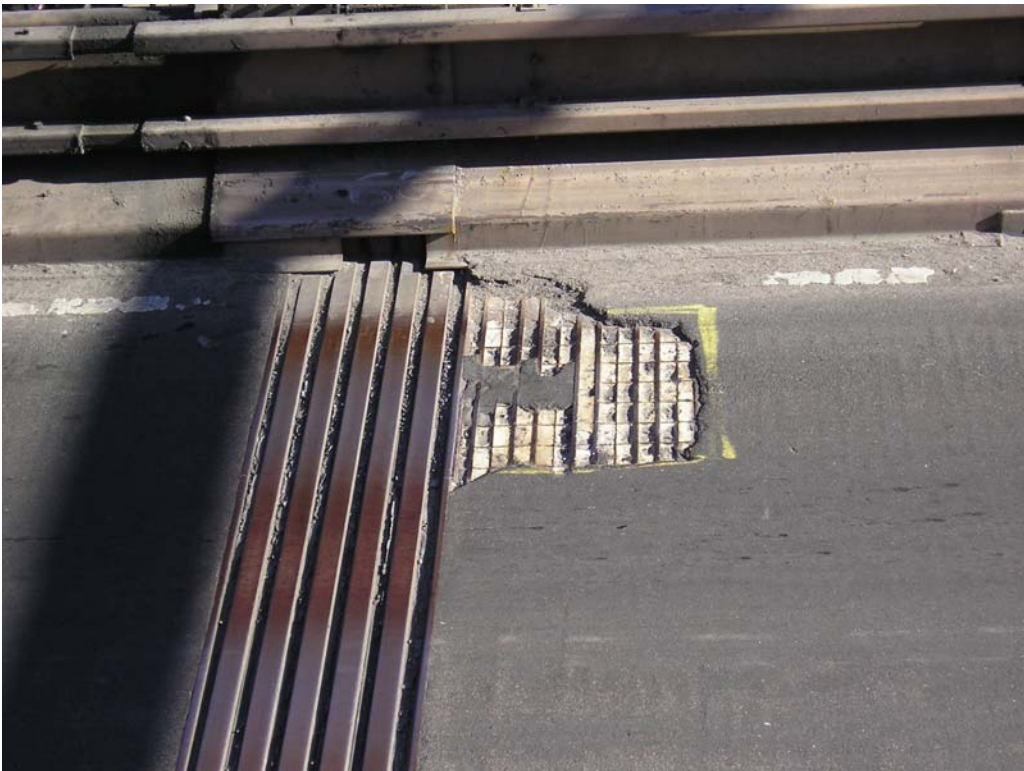
**FIGURE 2.6 Modular joint on Brooklyn Bridge deck.**

Modular joints, such as the one shown in Figure 2.6, are cleaned every 2 weeks, and a full wash-down of the entire bridge is performed once annually. The drainage system is vacuumed every 4 months. In order to minimize further damage to deteriorating paint, only sound paint is regularly washed. Full repainting is performed every 12 years, and spot repainting is performed every 3 years. A 6-ft to 7-ft high splash zone along the bridge is repainted every 6 years. A contract will be awarded to a private company in 2008 for paint maintenance.

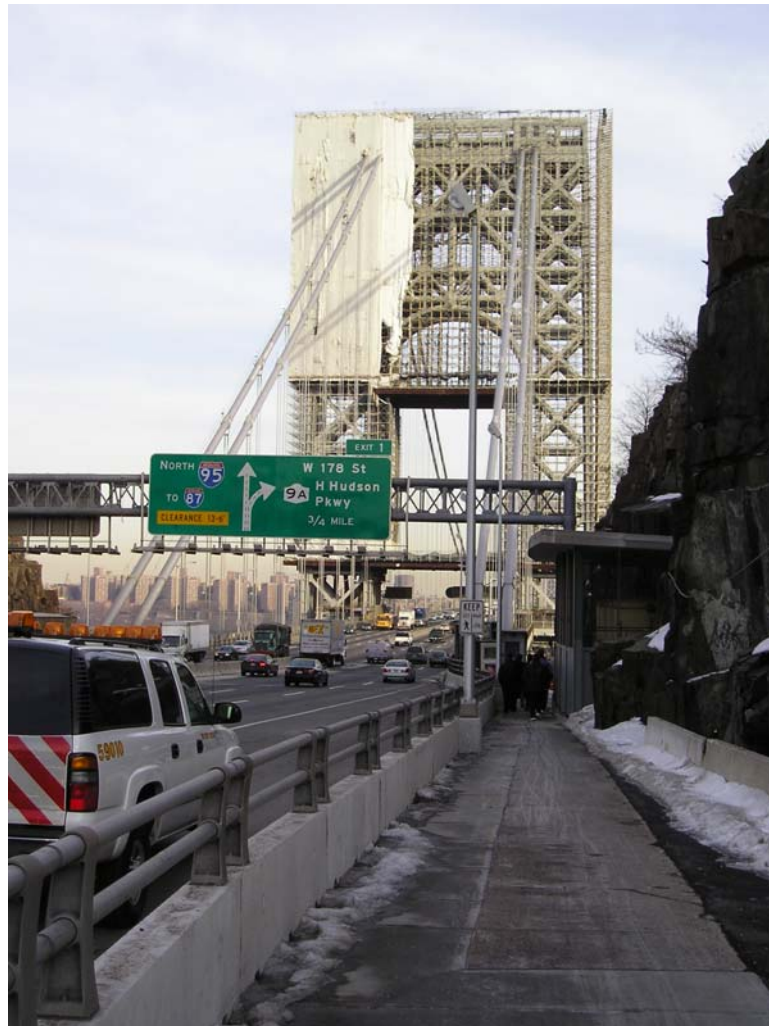
**FIGURE 2.7 George Washington Bridge.**

The scanning tour visit with the Port Authority of New York and New Jersey focused mainly on the George Washington Bridge, which was completed in 1931. Shown in Figure 2.7, the bridge boasts a clear span of 3,500 ft and has two

levels. The upper level has eight lanes, while the lower level has six lanes. The addition of the lower deck in 1965 was possible because the bridge structure was originally overdesigned, even by modern standards. The charge for passenger cars to cross the bridge is \$6, which is reduced to \$4 for EZ-Pass holders, but trucks are charged by the axle, with fees usually totaling greater than \$20 per truck. The ADT is 350,000; this traffic level generates annual revenues of \$460 million.

Deck joints are provided every 60 ft on the George Washington Bridge. Regarding joint performance, even small aberrations in joint smoothness, such as welding marks or the lugs on orthotropic decks, have caused leaking by interrupting adhesion. Therefore, according to Chan Patel of the Port Authority of New York and New Jersey, the decision was made to install Jeene joints in 1998. A picture of one of the Jeene joint installations is given in Figure 2.8. Patel explained that the Jeene joint possibly provides better results than a regular compression seal due to the inflation process used to install it. Inflating the joint during construction may facilitate a stronger bond between the joint material and the vertical deck surface to which it is epoxied.

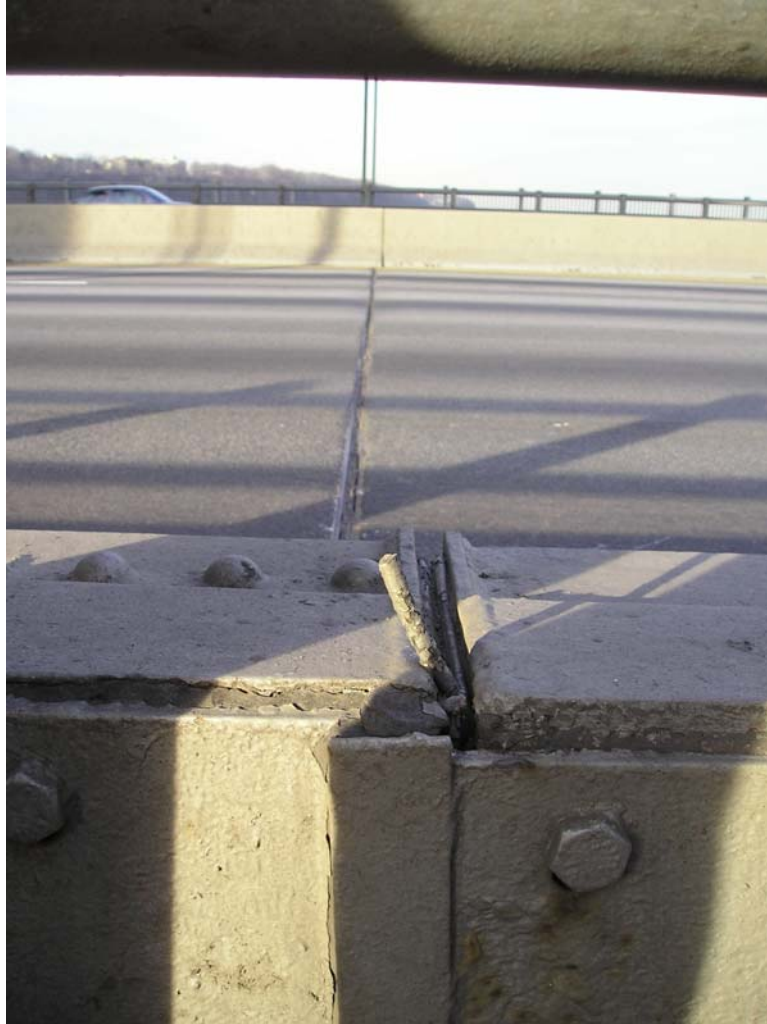
**FIGURE 2.8 Jeene joint on George Washington Bridge deck.**

This intuitive hypothesis was not supported by field data, however. The Jeene joints began leaking after just 5 months, and all of them failed in less than 1 year. Although the technicians had been trained by the supplier and supervised during the installation process, the company refused to honor the warranty given in the contract. Apparently cleaning the joint faces, which are comprised of weathering steel, had been extraordinarily difficult because the joint openings were typically less than 1 in., making sandblasting very ineffective; indeed, Patel called it a “total disaster.” Therefore, improper surface preparation was determined to be the cause of the premature failure. Working in night conditions probably also adversely impacted the quality of the work. The total cost of the joints was \$1.5 million.

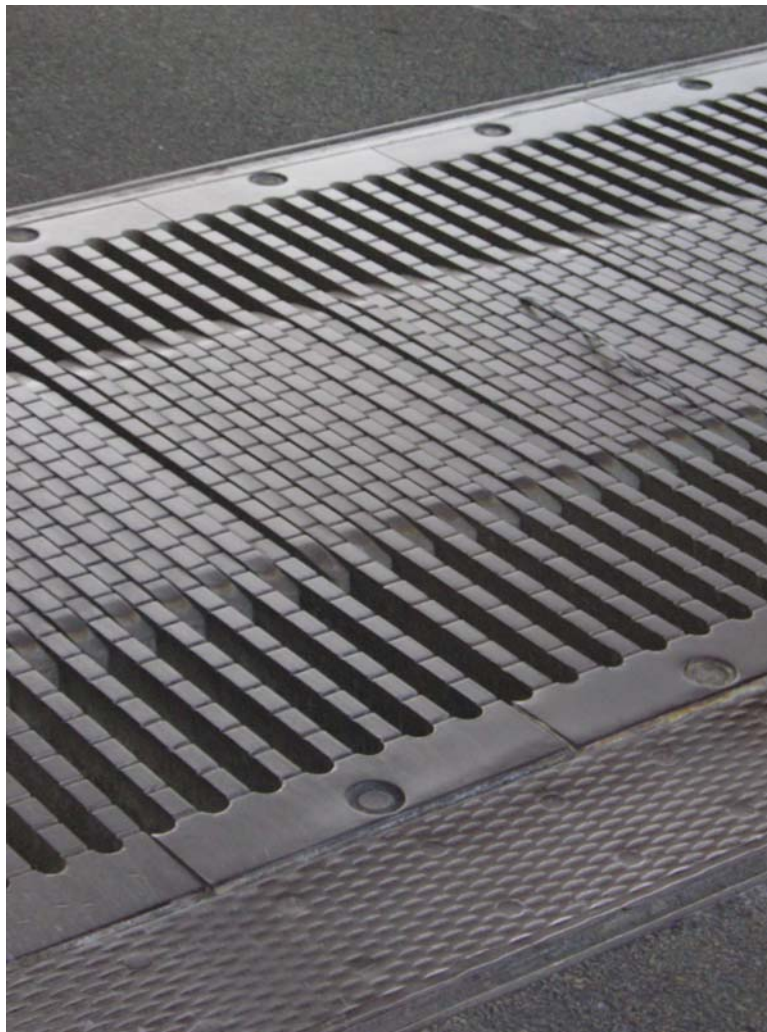
**FIGURE 2.9** Finger joint on George Washington Bridge deck.

retention of armor angles. The anchorage is tied to the stringers and also to the deck reinforcement. The reported total cost for strip seal installation on the George Washington Bridge is about \$3,000 to \$4,000 per lineal foot. Strip seals may last about 10 years, but the rail extrusions can last 20 years. For larger movements, on the order of 4 ft to 6 ft, finger joints have been used as depicted in Figure 2.9. Aluminum troughs are provided beneath the joints and are sufficiently large that a person can enter them to complete maintenance activities.

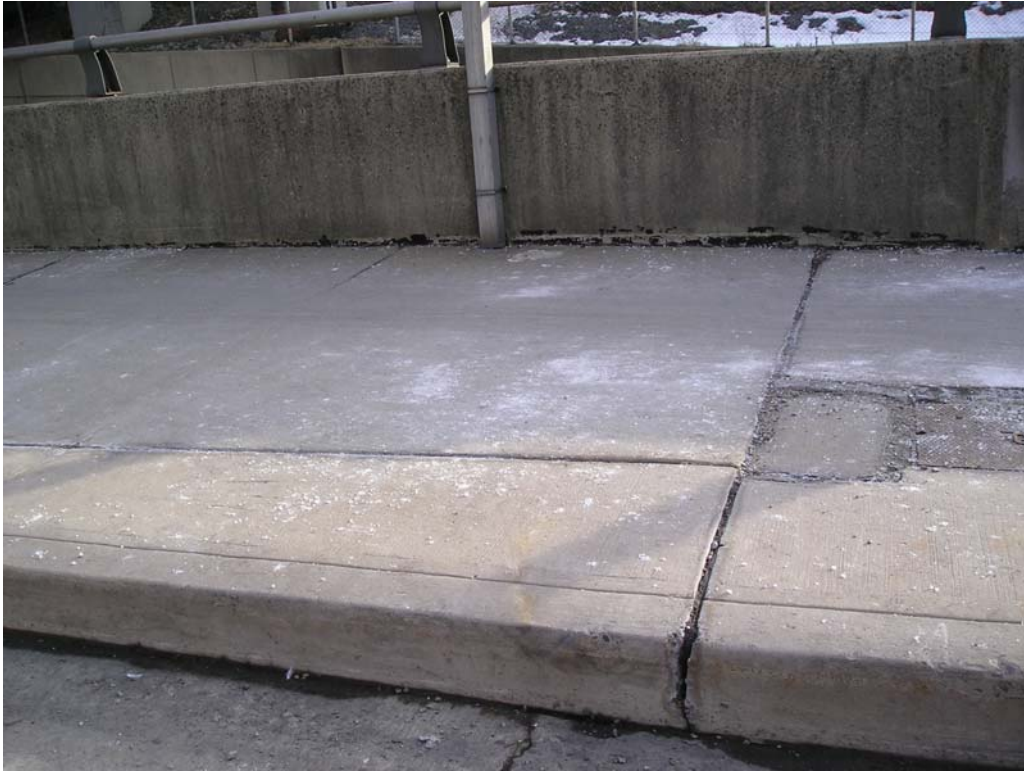
**FIGURE 2.10 Salt on pathway approaching George Washington Bridge.**

For surface treatments on the George Washington Bridge, methyl methacrylate has been used; also, wearing courses about 1.5 in. in thickness have been used. For surface deicing, sodium chloride salt is regularly applied to the deck; Figure 2.10 depicts salt crystals on a pathway approaching the George Washington Bridge. Surface icing is not as problematic as the accumulation of ice on the bridge superstructure elements, however. When such ice sheets fall, cars can be damaged, and accidents can occur.

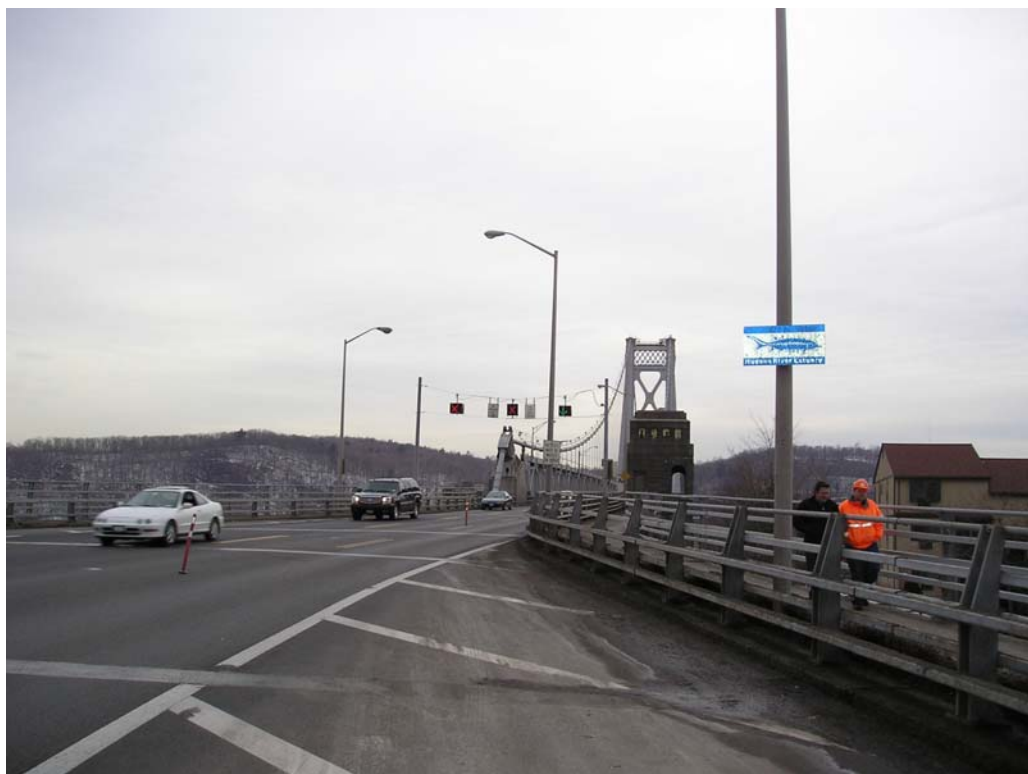
**FIGURE 2.11 Mid-Hudson Bridge.**

The scanning tour visit with the New York State Bridge Authority focused mainly on the Mid-Hudson Bridge, which is shown in Figure 2.11. Each of the cables in this cable-stayed bridge has 6,080 wires comprising it, which are anchored as illustrated in Figure 2.12. Maintenance activities cost about \$15 million annually for this bridge. Revenues from tolls amount to about \$40 million each year, with a charge of \$1 per vehicle. The ADT is 40,000.

According to William Moreau of the New York State Bridge Authority, the concrete-filled steel grid deck was installed in 1989, about 15 years previous to the scanning tour. An epoxy overlay was applied just after the deck replacement and failed rapidly. The overlay was constantly repaired for 5 years and then removed using hydrodemolition. The current surface treatment used to protect the deck is a Rosphalt Eliminator System, which is reportedly an expensive, spray-on membrane justified in this case because of the significance of this bridge. A wearing surface was placed on top of the membrane.

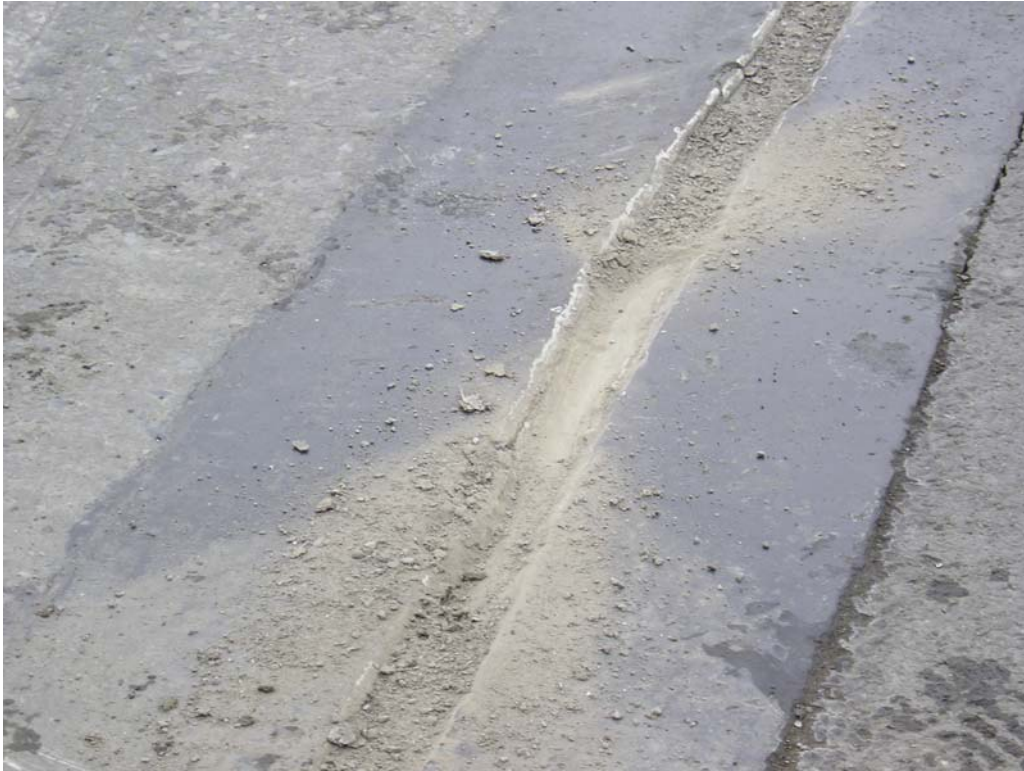
**FIGURE 2.15 Metazeal joint on NYDOT bridge deck.**

Information regarding specific NYDOT bridges inspected by the scanning tour members is given in Table 2.1, in which hyphens are given where data were not available or where the information was not applicable. Figures 2.15 to 2.22 show pictures of the tested joints. The silicone joints were Dow Corning 902 types. The mean annual air temperature in Poughkeepsie is 49°F, which is quite similar to the air temperatures measured at the time of inspection, so the joint widths were probably at approximately normal values. The silicone joints and XJS system with silicone collected more debris in the tested locations than the Metazeal or Silicoflex joints, probably because of the greater depth at which the silicone joints were installed. In addition, the presence of curbing on two of the three decks with silicone joints may have caused increases in debris entrapment

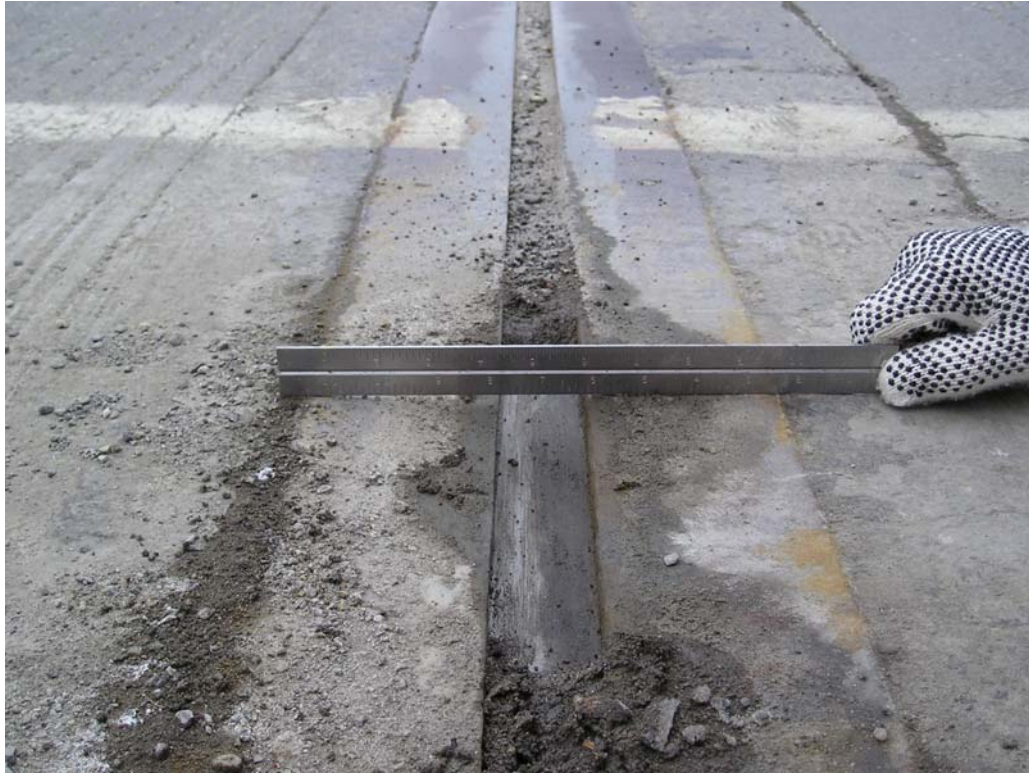
**FIGURE 2.20 Silicone joint on NYDOT bridge deck.**

compared to decks without curbs. All five of the inspected joints appeared to be intact, however, and NYDOT personnel were apparently pleased with their performance thus far.

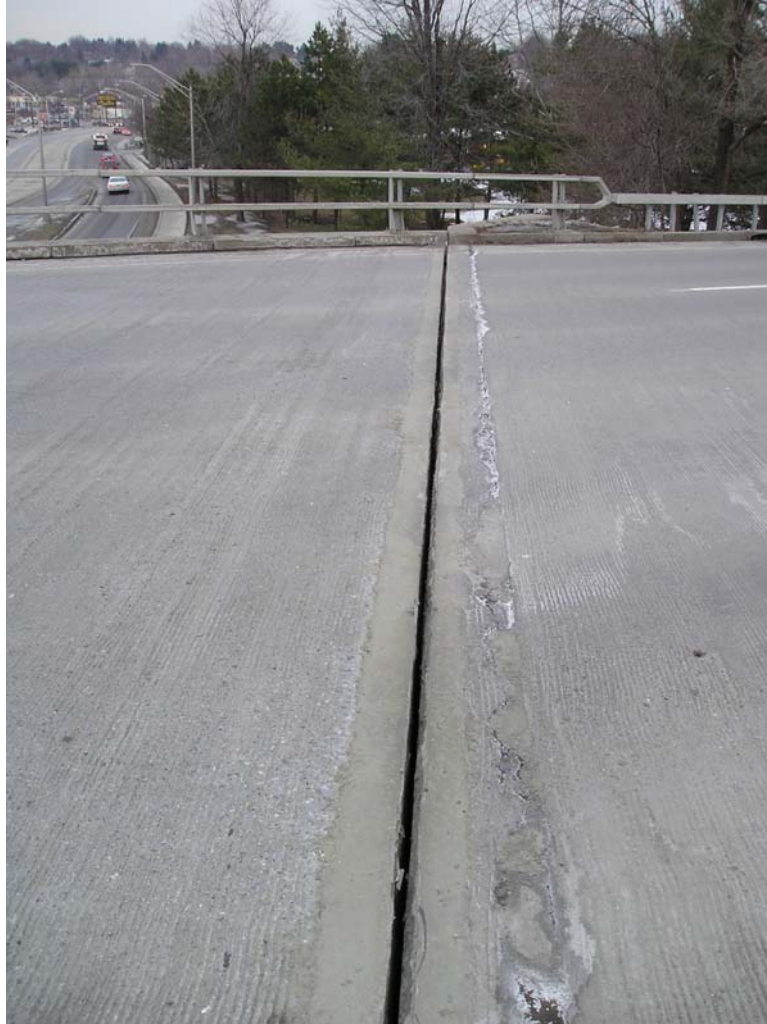
**FIGURE 2.23 Failed Matrix Blue joint.**

In addition to the five NYDOT bridge joints inspected during the visit, a Matrix Blue product was discussed. Weykamp described it as a polysulfide urethane with a backer rod; it failed by debonding during the first spring after installation and had actually been removed or fallen from the joint at the time of the site visit as shown in Figure 2.23. Urethanes are apparently very sensitive to the moisture condition of the substrate, and in this case the joint faces had not been properly prepared.

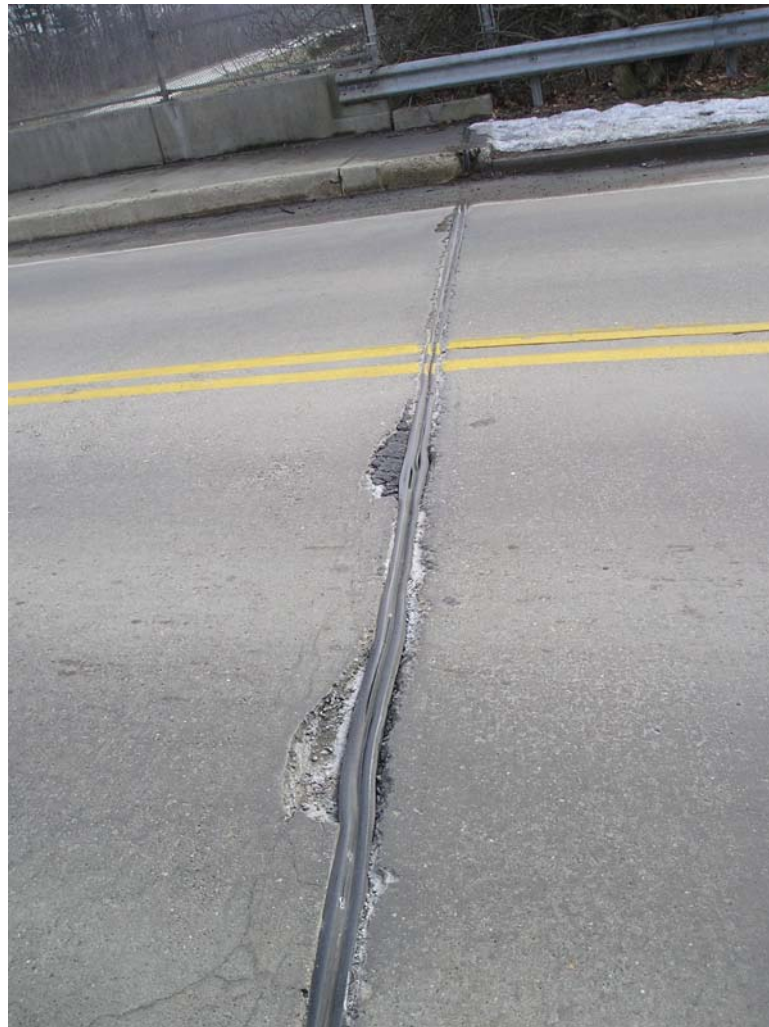
**FIGURE 2.26 Deteriorated compression seal on NJDOT bridge deck.**

sensitive to substrate preparation, shape factor, and joint opening size. For example, he claimed that, although the North Carolina Department of Transportation still permits the use of Evazote, the Maryland Department of Transportation now prohibits its use. Kaczinski suggested that the initial costs of joints too often drive product selection when life-cycle costs should be the actual basis for decision-making. Indeed, NJDOT bridge engineers reported that compression seals begin leaking within 2 years after installation. Examples of deteriorated compression seals inspected on NJDOT bridge decks during the scanning tour are shown in Figures 2.26 and 2.27.

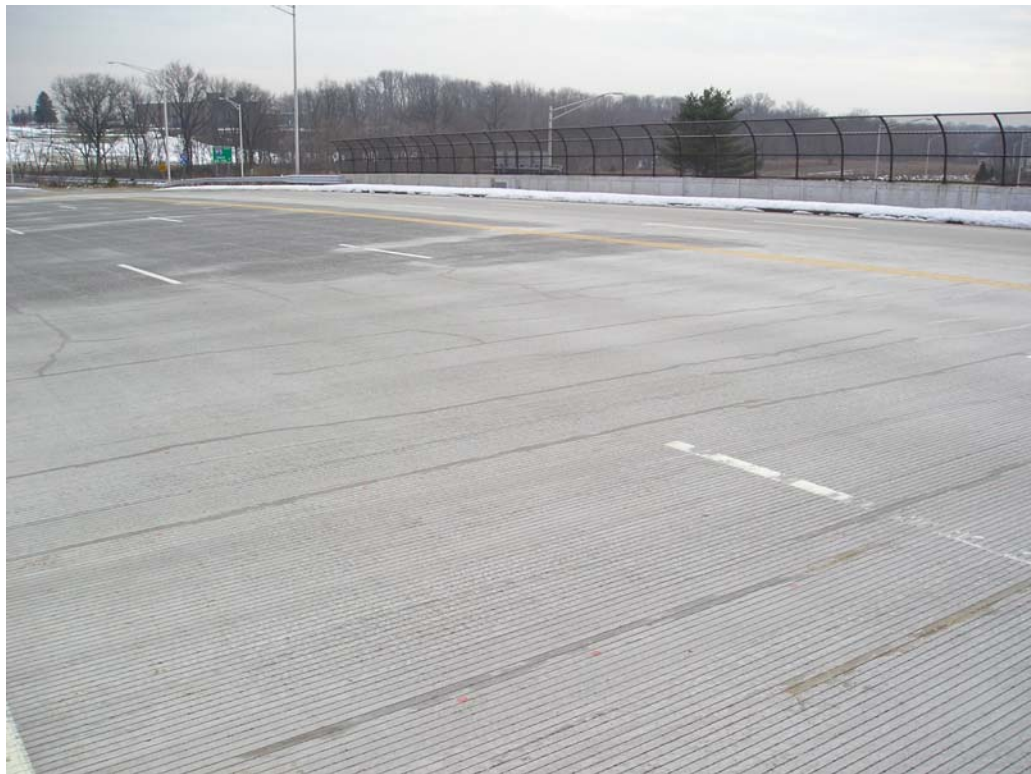
**FIGURE 2.28 Cracking in new NJDOT bridge deck.**

New deck construction utilizes high-performance concrete with 9.5-in.-thick decks. Because Type III Portland cement is reportedly unavailable in New Jersey, high amounts of Type I and Type II Portland cements are typically used to produce high early strengths; the high-performance concrete specification has been in use as a standard since about 2003. NJDOT engineers have noted that high-performance concrete and their “Class A” concrete both experience cracking as displayed in Figure 2.28, presumably due to a combination of hydration and evaporation shrinkage. Both epoxy and galvanized reinforcing bars are specified for new construction, although the latter is less common due to

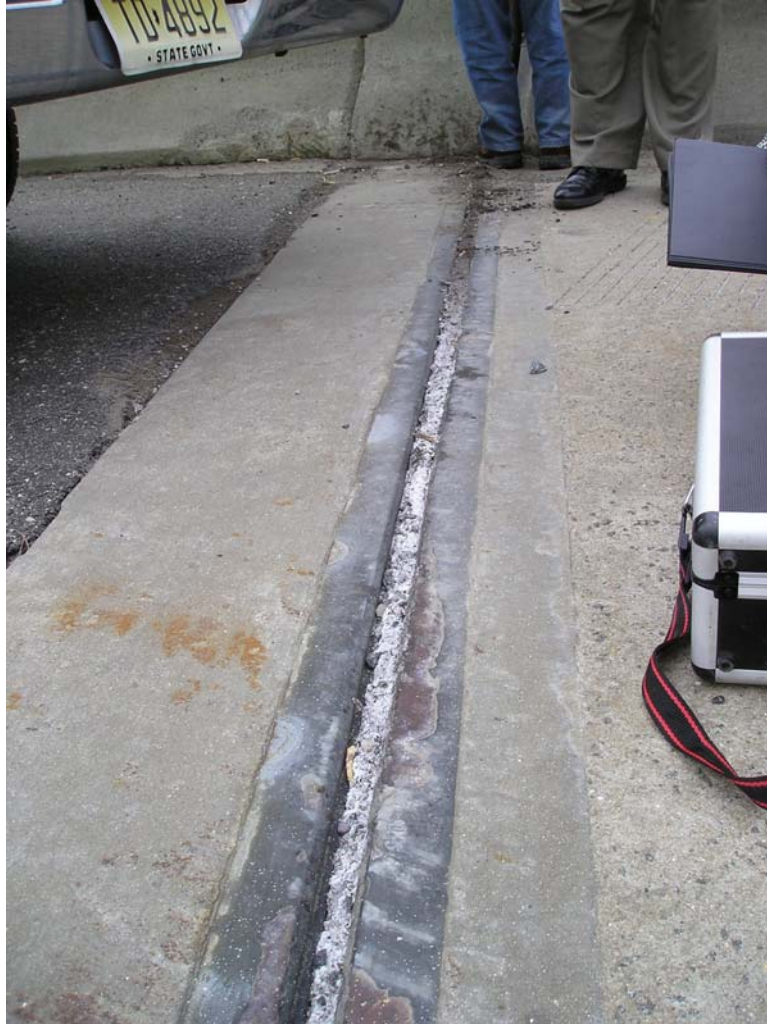
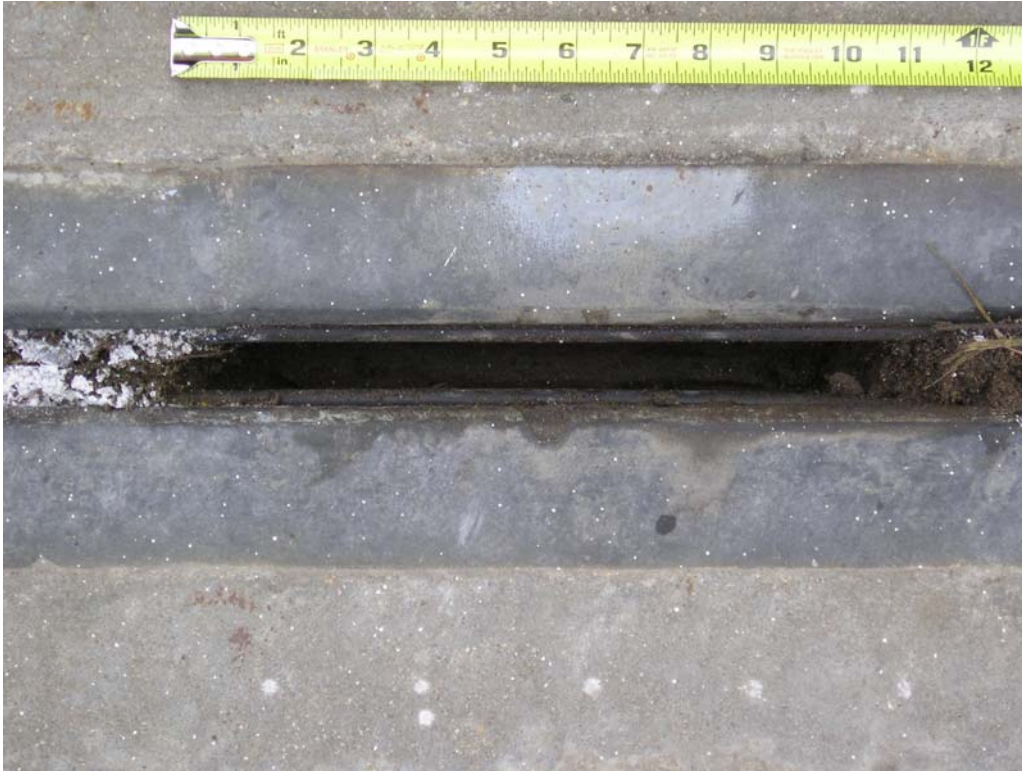
**FIGURE 2.29 Strip seal on NJDOT bridge deck.**

Description	Facility
	Dunns Mill Rd/295
Joint Type	Strip Seal
Joint Age (yr)	11
Air Temperature (°F)	53
Oven-Dry Weight of Debris (lb/lineal in.)	0.17
Presence of Curb	Yes
Depth to Top of Joint (in.)	-
Depth to Bottom of Folded Joint (in.)	3.26
Width of Joint (in.)	1.20
Depth of Armor below Concrete (in.)	0.05
Schmidt Rebound Number for Header	34
Schmidt Rebound Number for Concrete	31

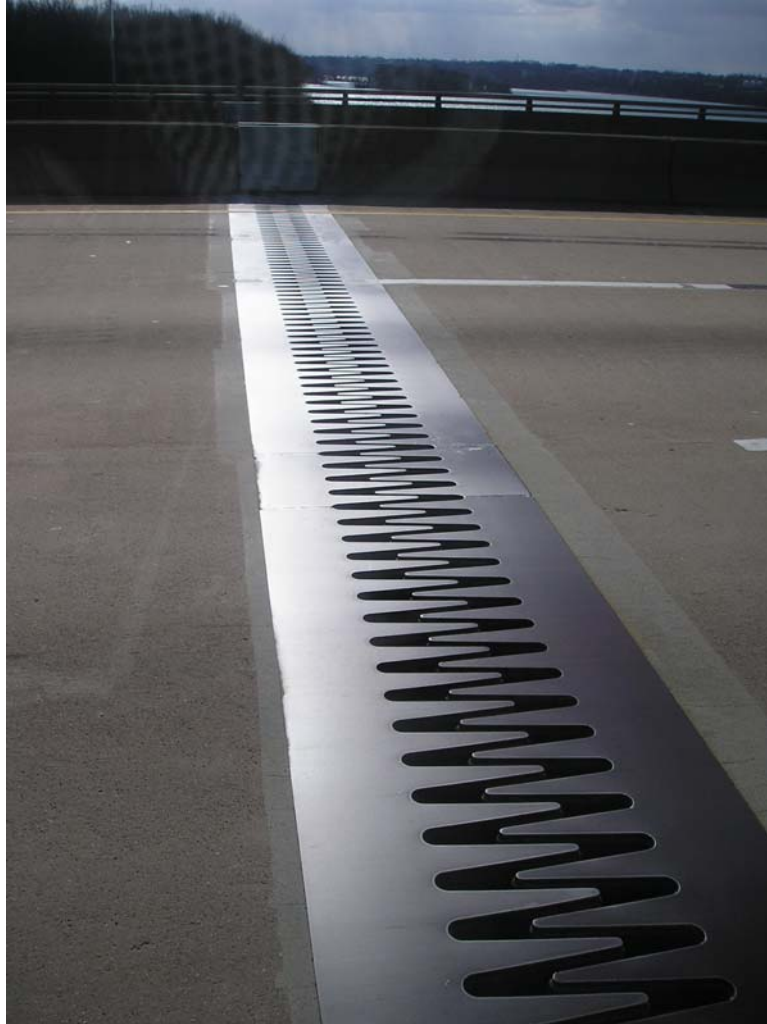
**FIGURE 2.31 Debris in finger joint on PennDOT bridge deck.**

In addition to strip seals, PennDOT has installed finger joints with troughs and some modular joints. Example finger joints are depicted in Figures 2.31 and 2.32. The troughs used in conjunction with the finger joints are commonly constructed of neoprene and installed with a 1:12 slope. Each trough is routinely cleaned at the end of each winter. In one case, the first time a trough was cleaned, maintenance personnel had to partially disassemble the joint to remove

pigeon nests and other debris that had blocked the drainage. Figure 2.33 shows a trough beneath a finger joint. PennDOT participated in early research on modular joints and concluded that poor design, low-quality components, and poor installation were all responsible for the inadequate joint performance observed in their studies; based on this experience, PennDOT is “staying away” from modular joints at the present time. Therefore, for deck movements exceeding 5 in., finger joints are currently specified.

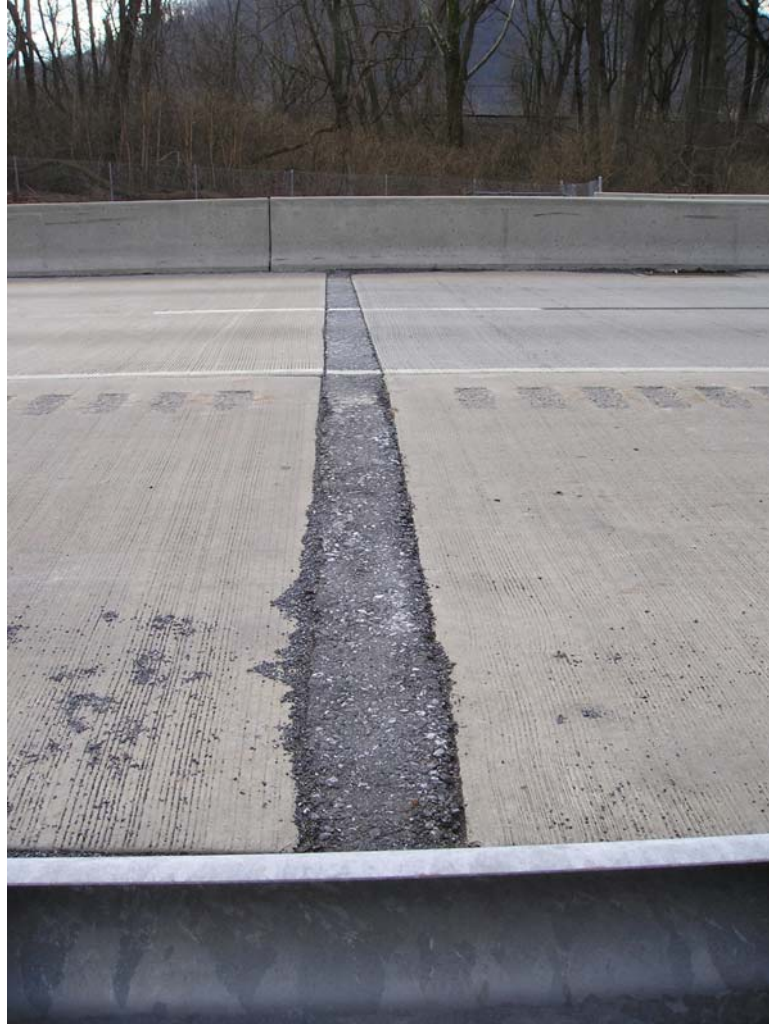
**FIGURE 2.34 Asphalt plug joint on PennDOT bridge deck.**

Regarding other joint types, one Silicoflex joint was installed by PennDOT in 1999, and asphalt plug joints, such as the one shown in Figure 2.34, are often

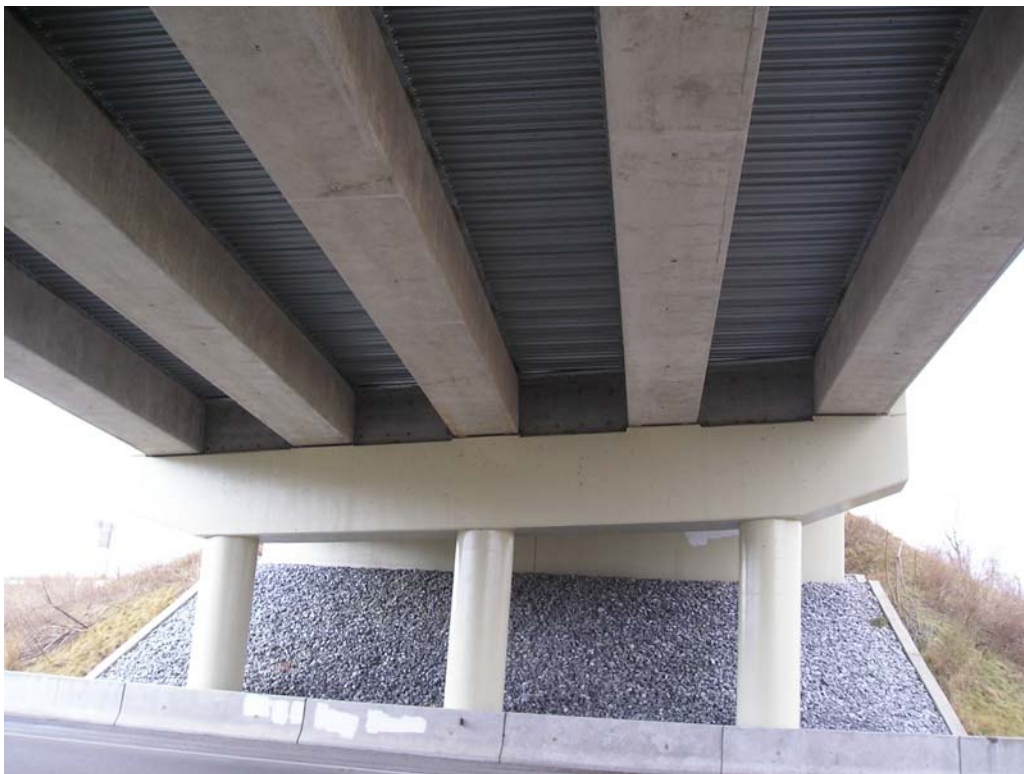
**FIGURE 2.35 Stay-in-place metal forms on PennDOT bridge deck.**

PennDOT has been using stay-in-place metal forms (SIPMFs), as depicted in Figure 2.35, for more than 30 years and has not received any reports suggesting that the presence of the forms causes accelerated corrosion of the steel deck reinforcement. While the inability to inspect the lower concrete surface of decks with SIPMFs is admittedly a problem, PennDOT engineers explained that localized rusting and failure of the galvanized SIPMFs is a reliable indicator of deck failure in cases where failure is associated with water flow through the deck. PennDOT also applies overlays to decks with SIPMFs, even though this practice further reduces the efficacy of visual inspections. To discuss design and construction details for bridges and other structures, PennDOT participates in a meeting twice a year with other states in the New England area, including Delaware, the District of Columbia, Maryland, New Jersey, New York, Virginia, and West Virginia.

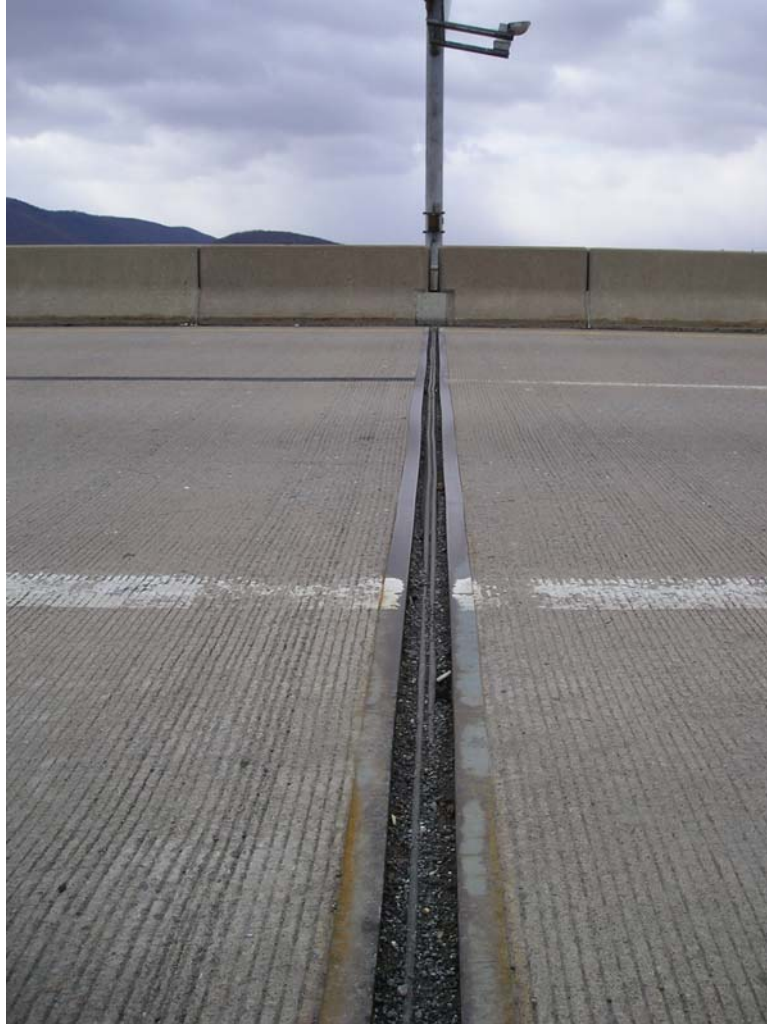
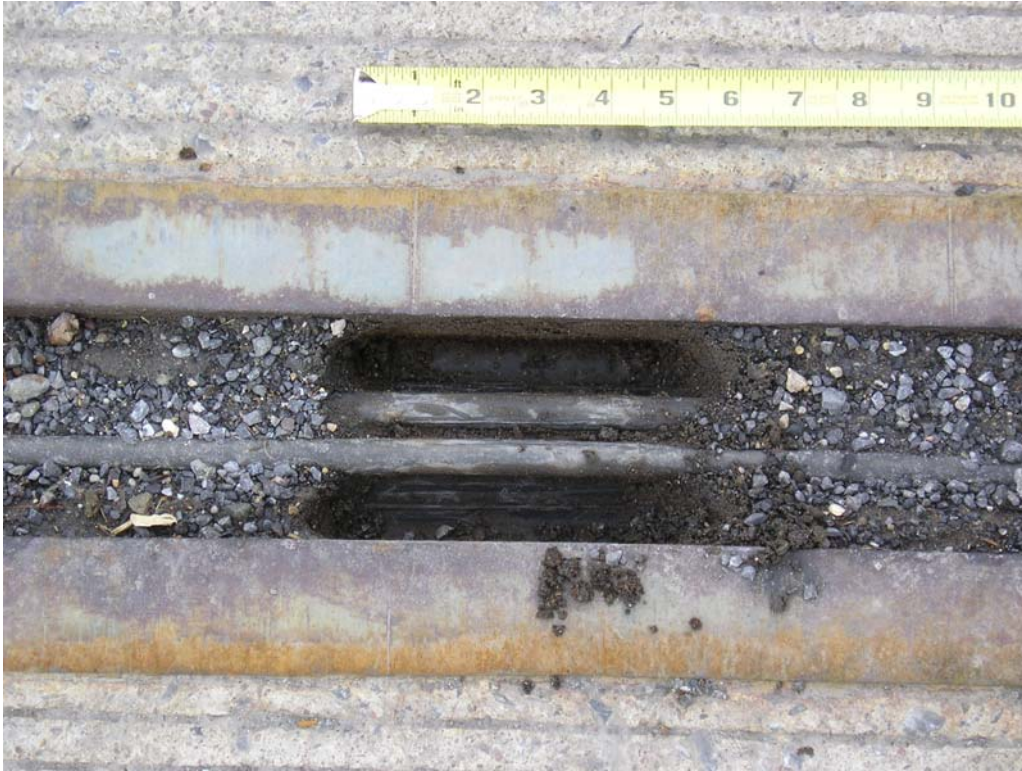
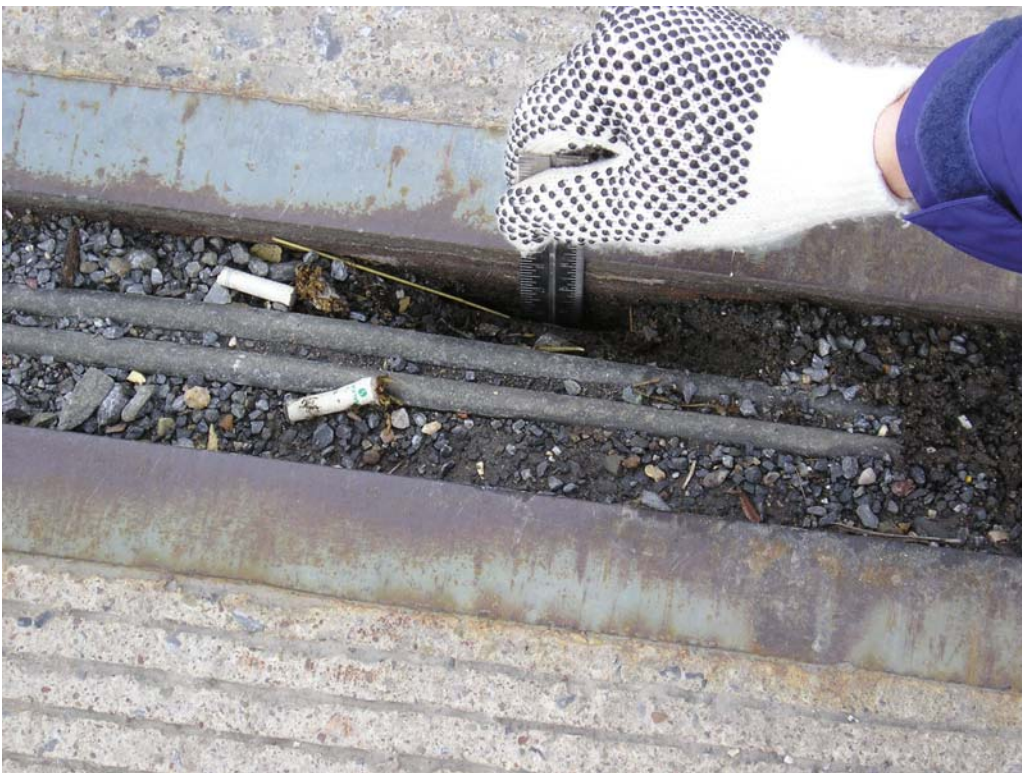
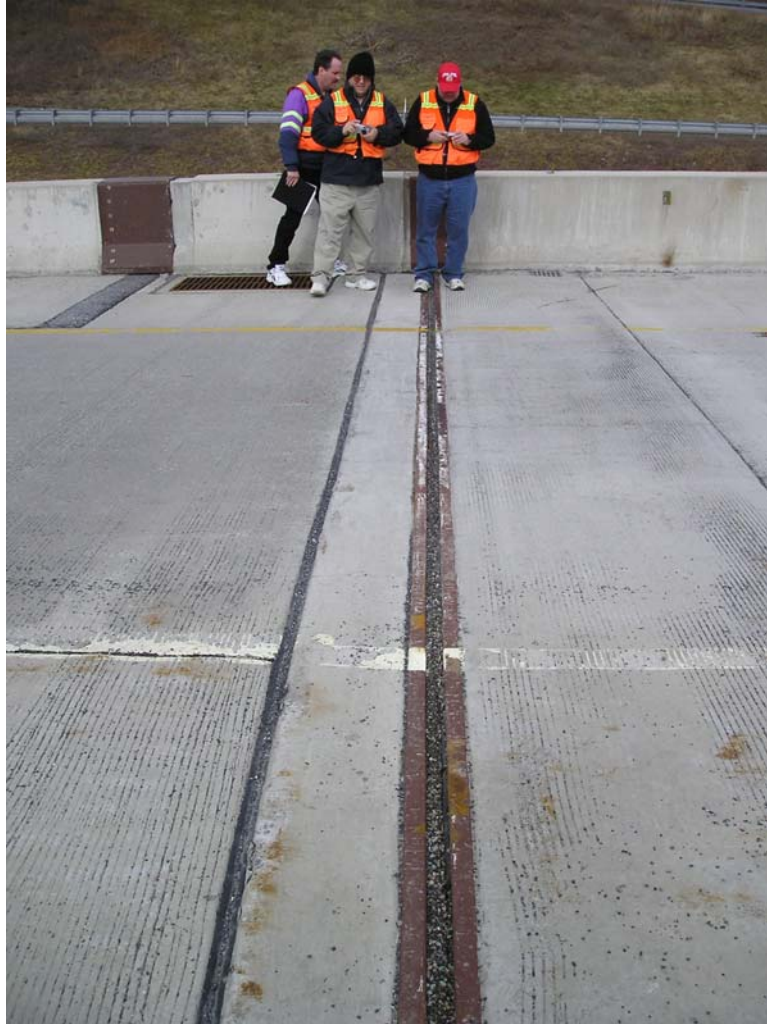
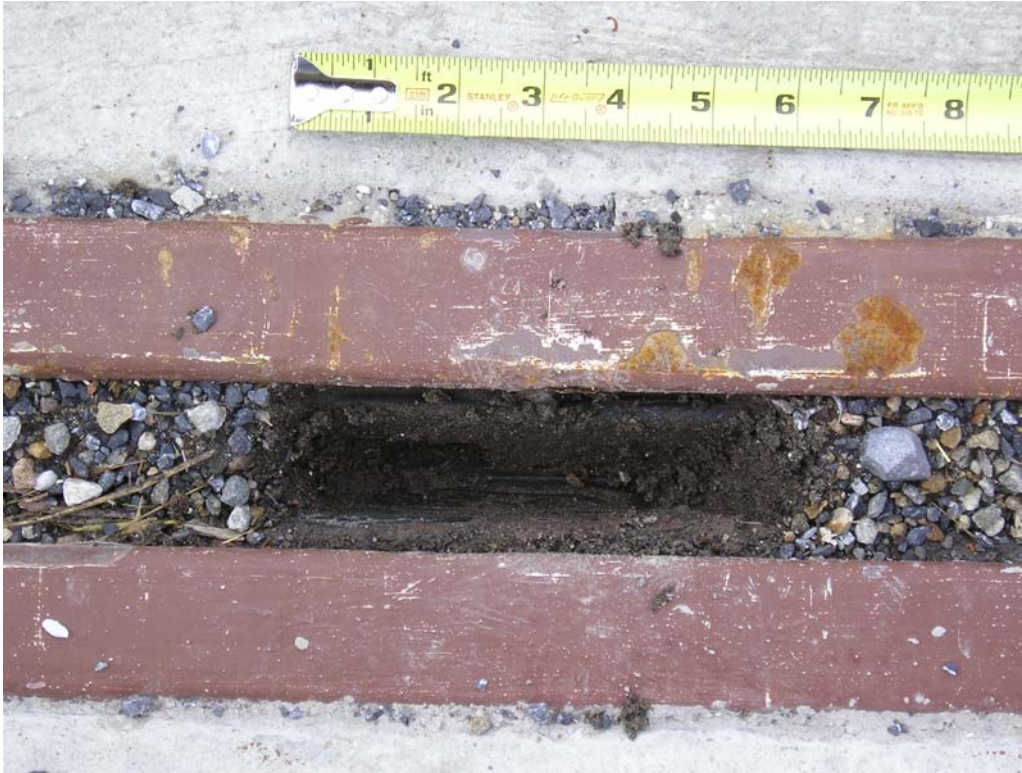
Information regarding specific PennDOT bridges inspected by the scanning tour members is given in Table 2.3, and Figures 2.36 through 2.40 illustrate decks tested in Pennsylvania. As stated previously, hyphens are given

Description	Facility	
	US 22/Susquehanna River	Ramp/US 22
Joint Type	Silicoflex	Strip Seal
Joint Age (yr)	5	5
Air Temperature (°F)	40	40
Oven-Dry Weight of Debris (lb/lineal in.)	0.16	0.12
Presence of Curb	Yes	Yes
Depth to Top of Joint (in.)	0.58	-
Depth to Bottom of Folded Joint (in.)	1.80	2.85
Width of Joint (in.)	3.50	1.94
Depth of Armor below Concrete (in.)	-	-
Schmidt Rebound Number for Header	-	-
Schmidt Rebound Number for Concrete	-	-

where data were not available or where the information was not applicable. The mean annual air temperature in Harrisburg is 51°F, so the joints were more open than normal during testing. The joints collected similar amounts of debris, even though the Silicoflex joint was substantially wider. The Silicoflex joint was debonded from the armor angle in one location as indicated in Figure 2.38, but otherwise both joints seemed to be performing satisfactorily.

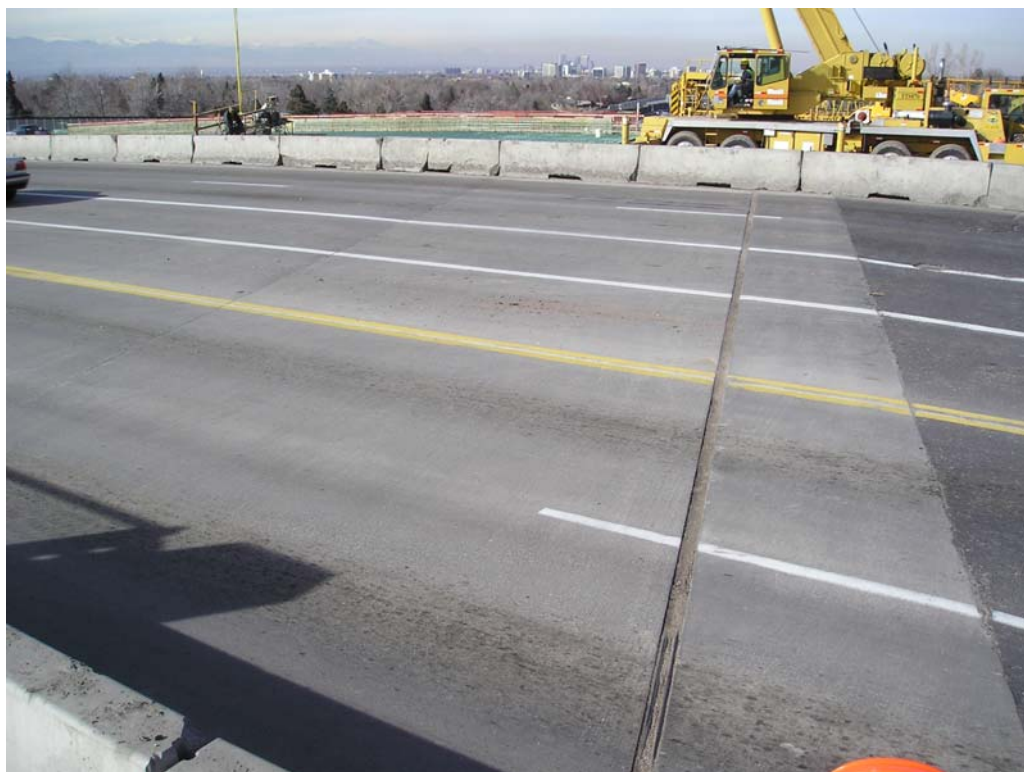
**FIGURE 2.42 Compression seal on CDOT bridge deck.**

Regarding expansion devices, CDOT classifies joint movements into three categories: 0 to 2 in., 0 to 4 in., and 4 in. or greater. In the first category, asphalt plug joints are used if bridge skews are less than 15 to 20 degrees and the joint movement is less than 1 in.; otherwise, compression seals may be used. An asphalt plug joint installed on a skewed angle is shown in Figure 2.41, and a compression seal is shown in Figure 2.42. Strip seals are primarily used in the second category, and modular joints are generally used in the third category.
